# SoCal STRUCTURAL

DEVELOPED BY JEREMY LIVERMORE, SE, PE

## GUIDELINE FOR HOW AN ENGINEER DETERMINES IF FOUNDATION SETTLEMENT WARRANTS A RETROFIT

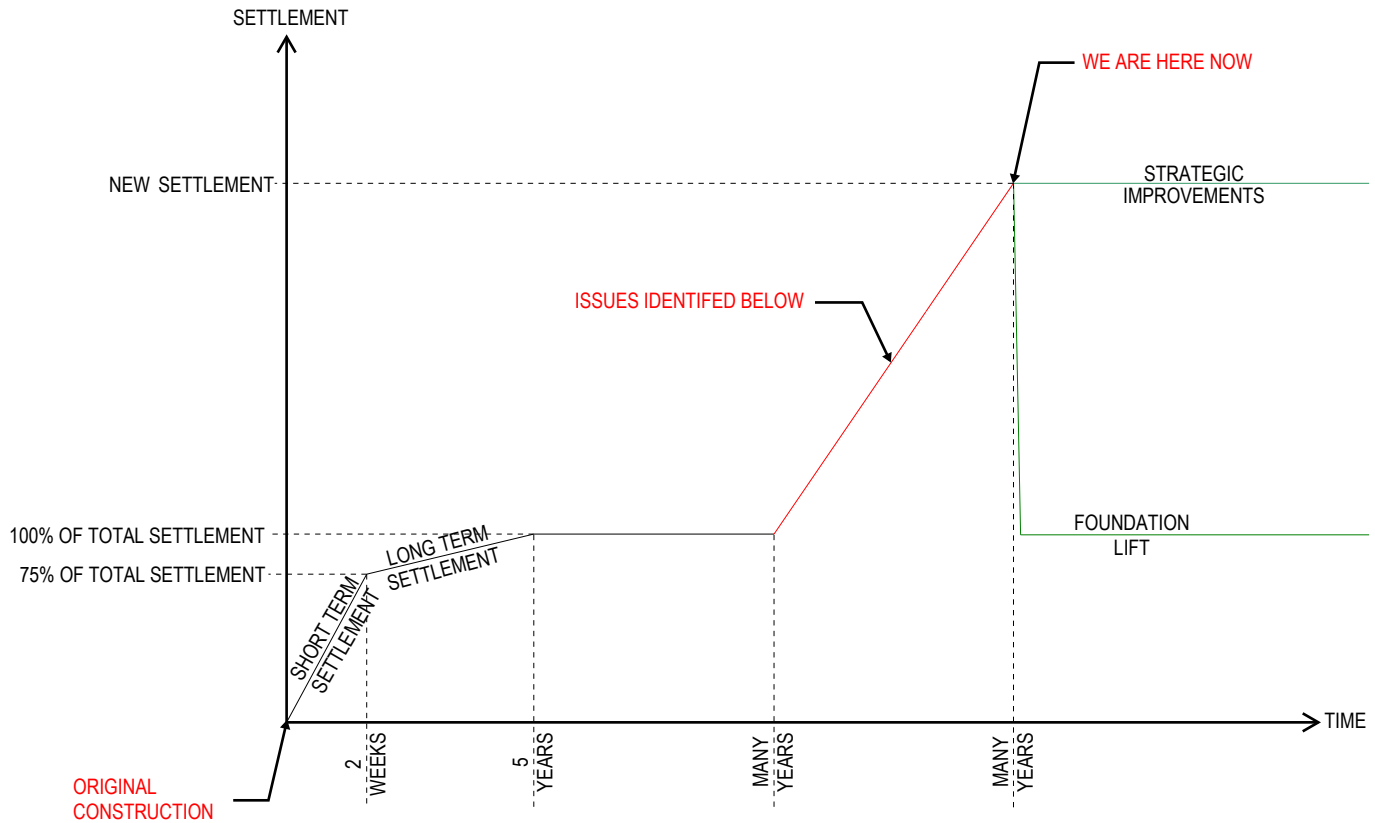
## SETTLEMENT OVER TIME

Differential settlement occurs when soil under a footing compresses, consolidates, or moves. The cause of soil compression or consolidation could be either:

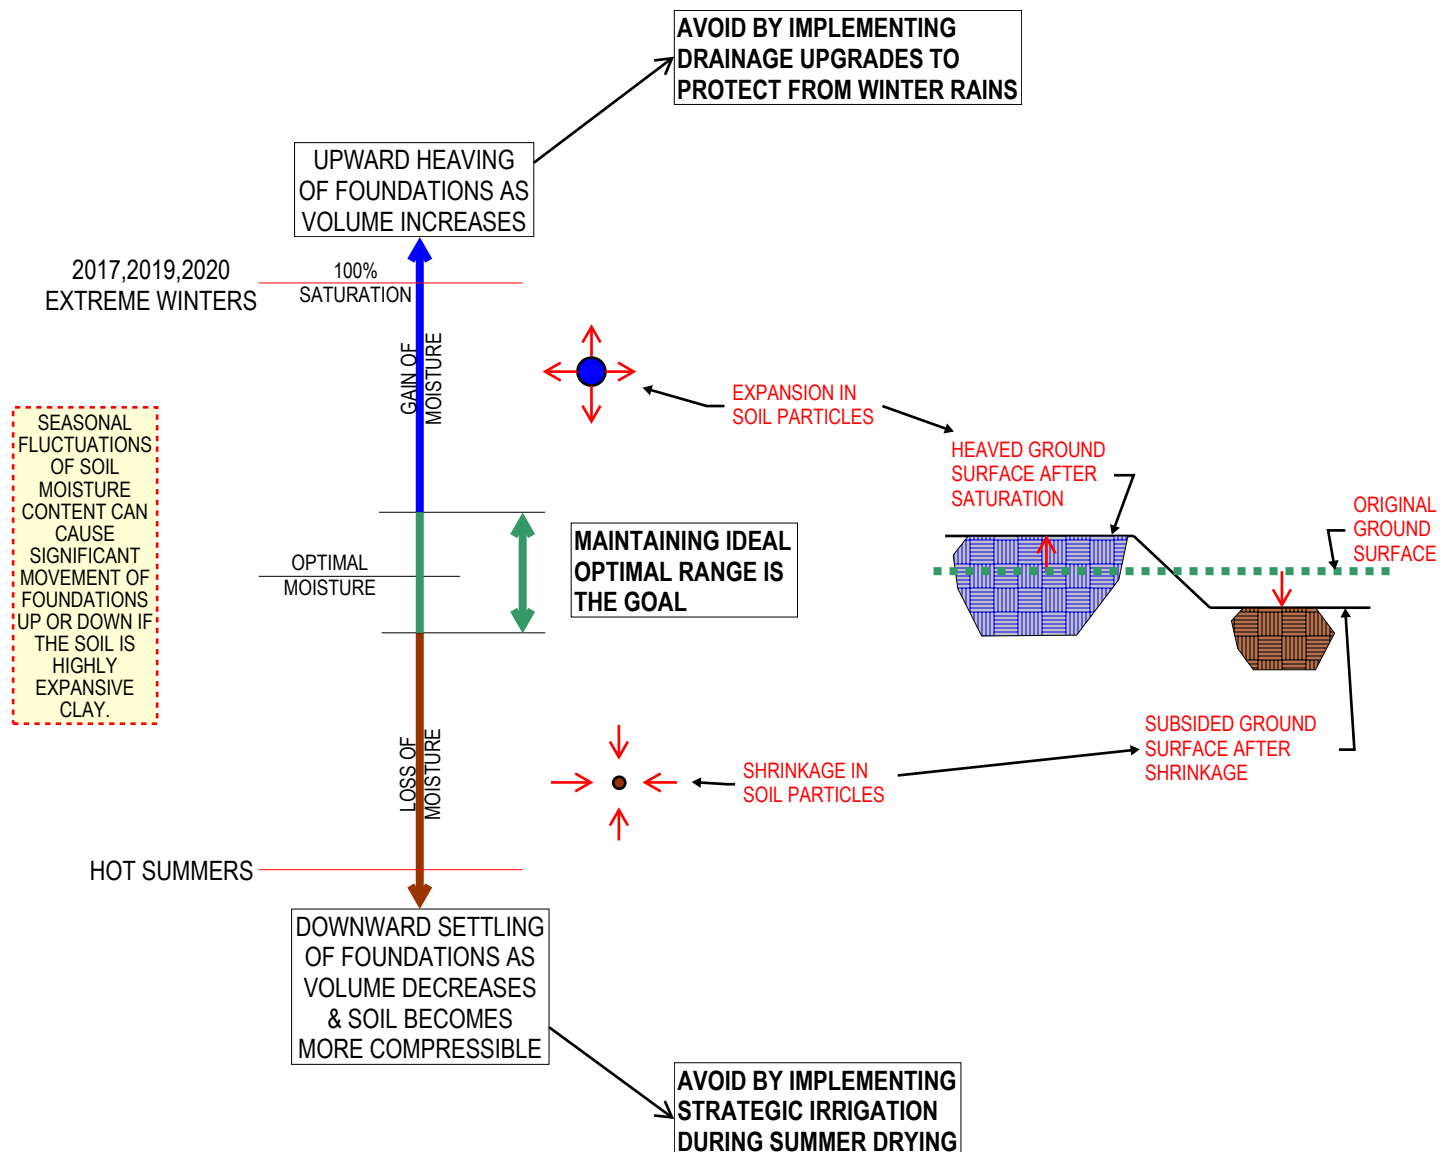
## CLAY SOIL EXPANSION-CONTRACTION SPECTRUM

b) Clayey soils have a high expansion and contraction rate. Upon moistening, these soils expand. This diagram is for soil not loaded from the top with gravity forces such as the weight of the house. See next diagram for that.
